GLOBAL ENVIRONMENTAL ASSESSMENTS AND RESPONSE

COX CREEK MONITORING REPORT

SUBMITTED:
May 15, 2023

May 10, 2023

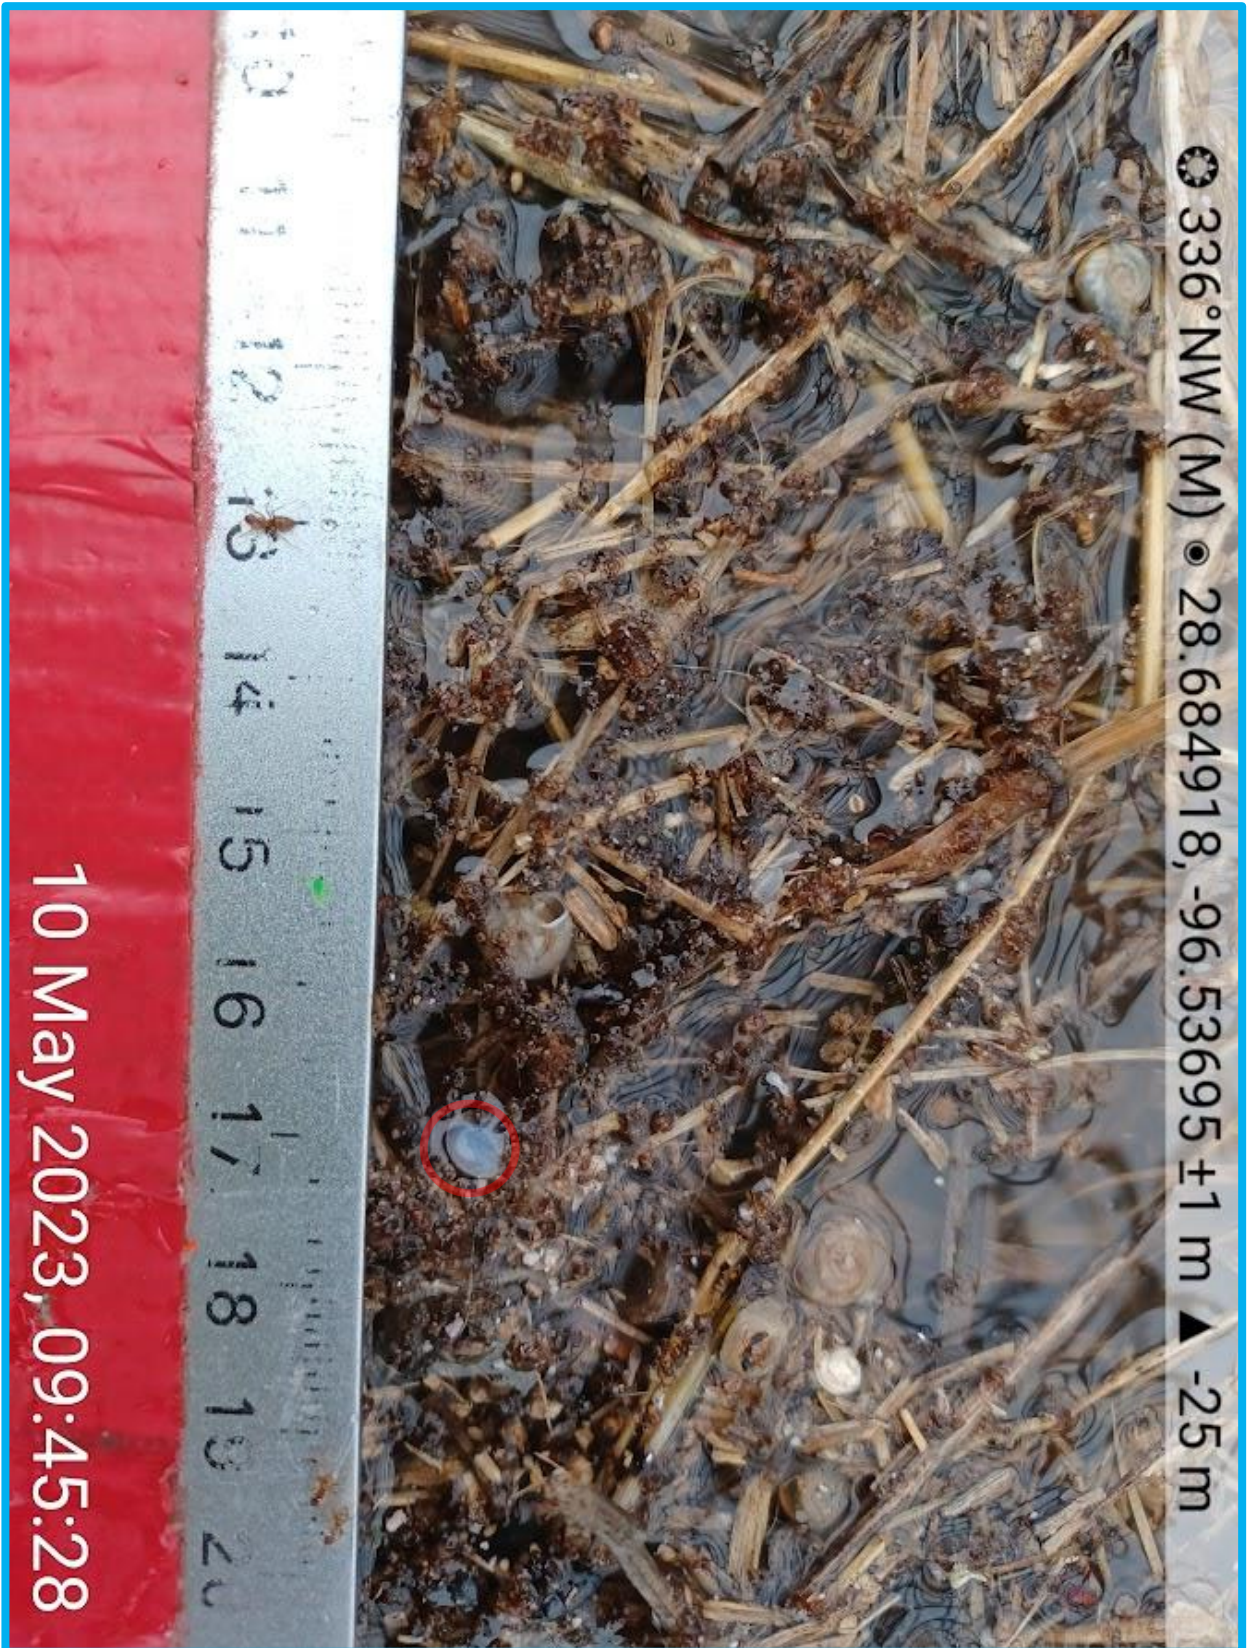
OUTFALL	LAT/ LONG	DESCRIPTION	PHOTO ID	EVIDENCE OF NEW DISCHARGE³ (Yes/No/ Undetermined)
2/4/5	28.684918, -96.53695	Plastic pellets observed at base of fence, in debris, in center of outfall	2023-05-10_245a	Yes

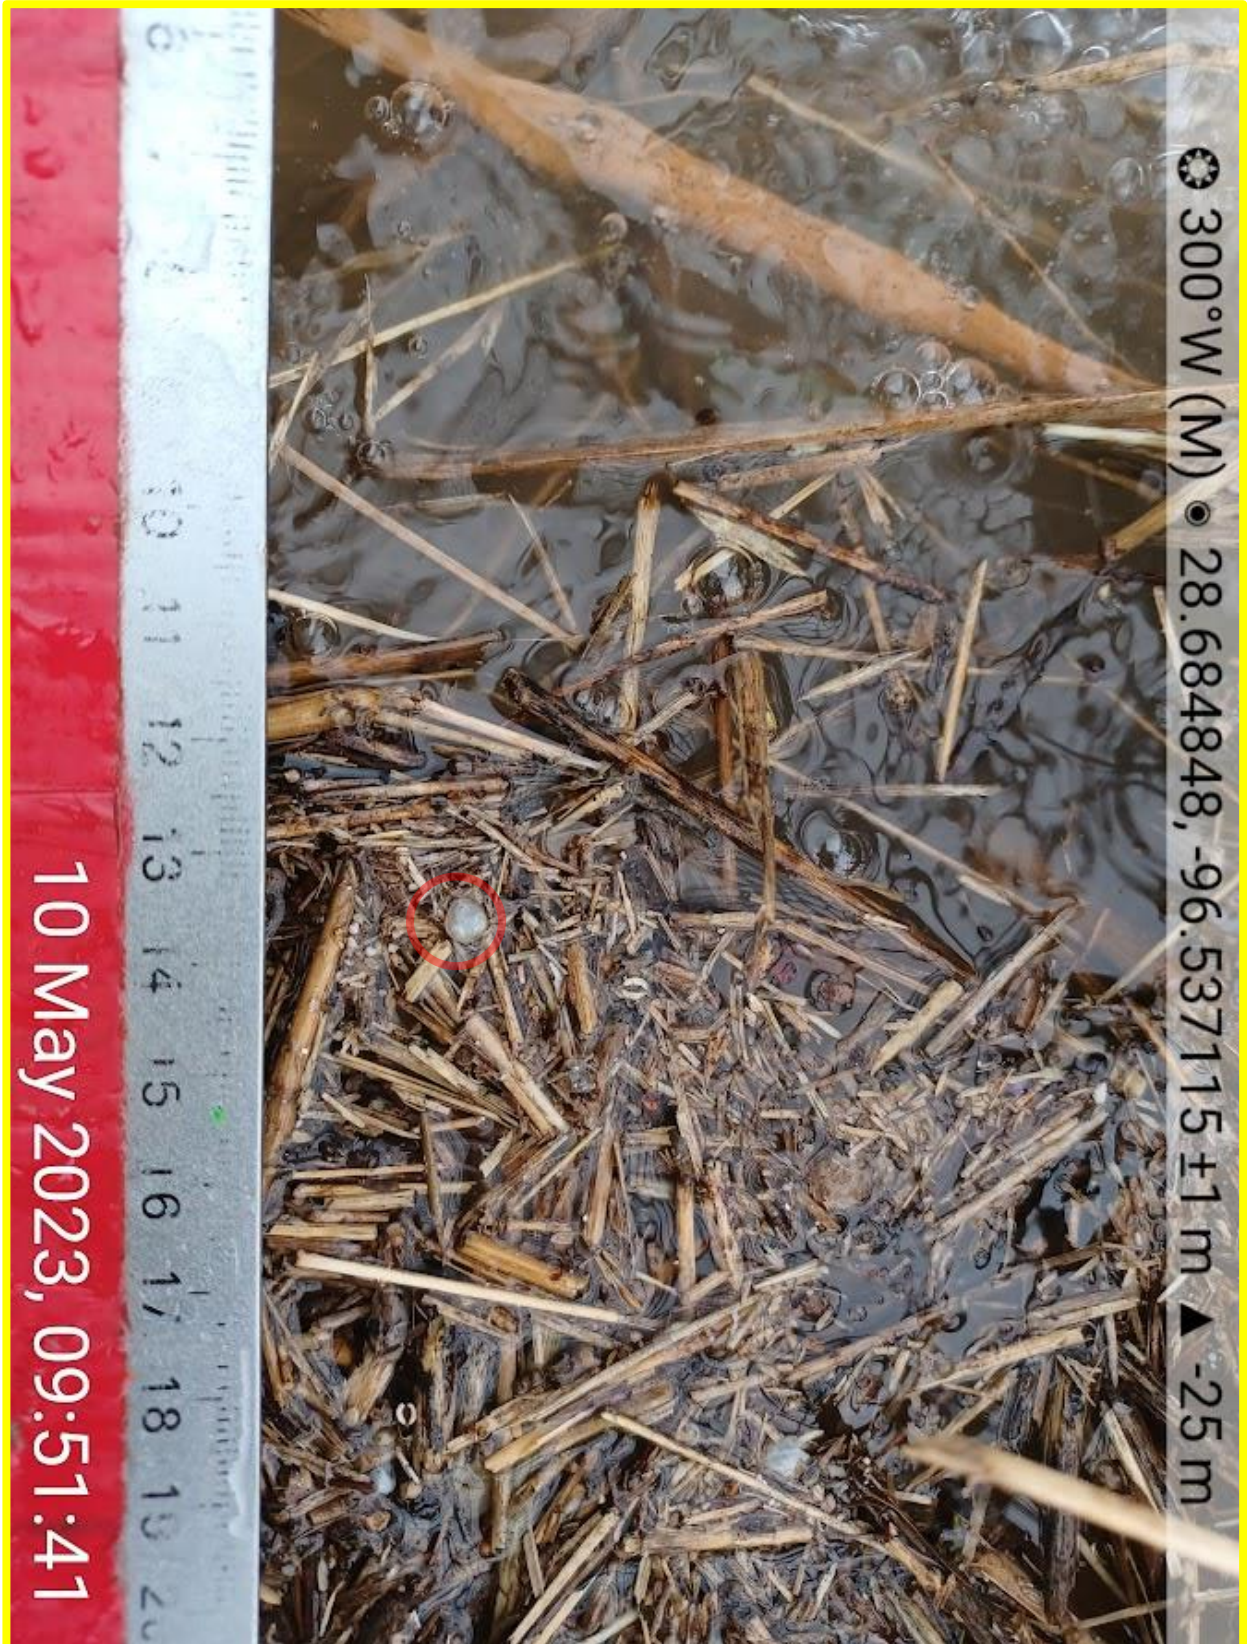
28.684868, -96.53709	Plastic pellets observed at base of fence, in debris, in center of outfall	2023-05-10_245b	Yes
003	28.6796, -96.548115	Plastic pellets observed in outfall channel, in debris line, 1ft from fence	2023-05-10_003	Yes
006	28.688725, -96.529258	Plastic pellets observed at base of fence, 30ft S of outfall channel	2023-05-10_006a	No

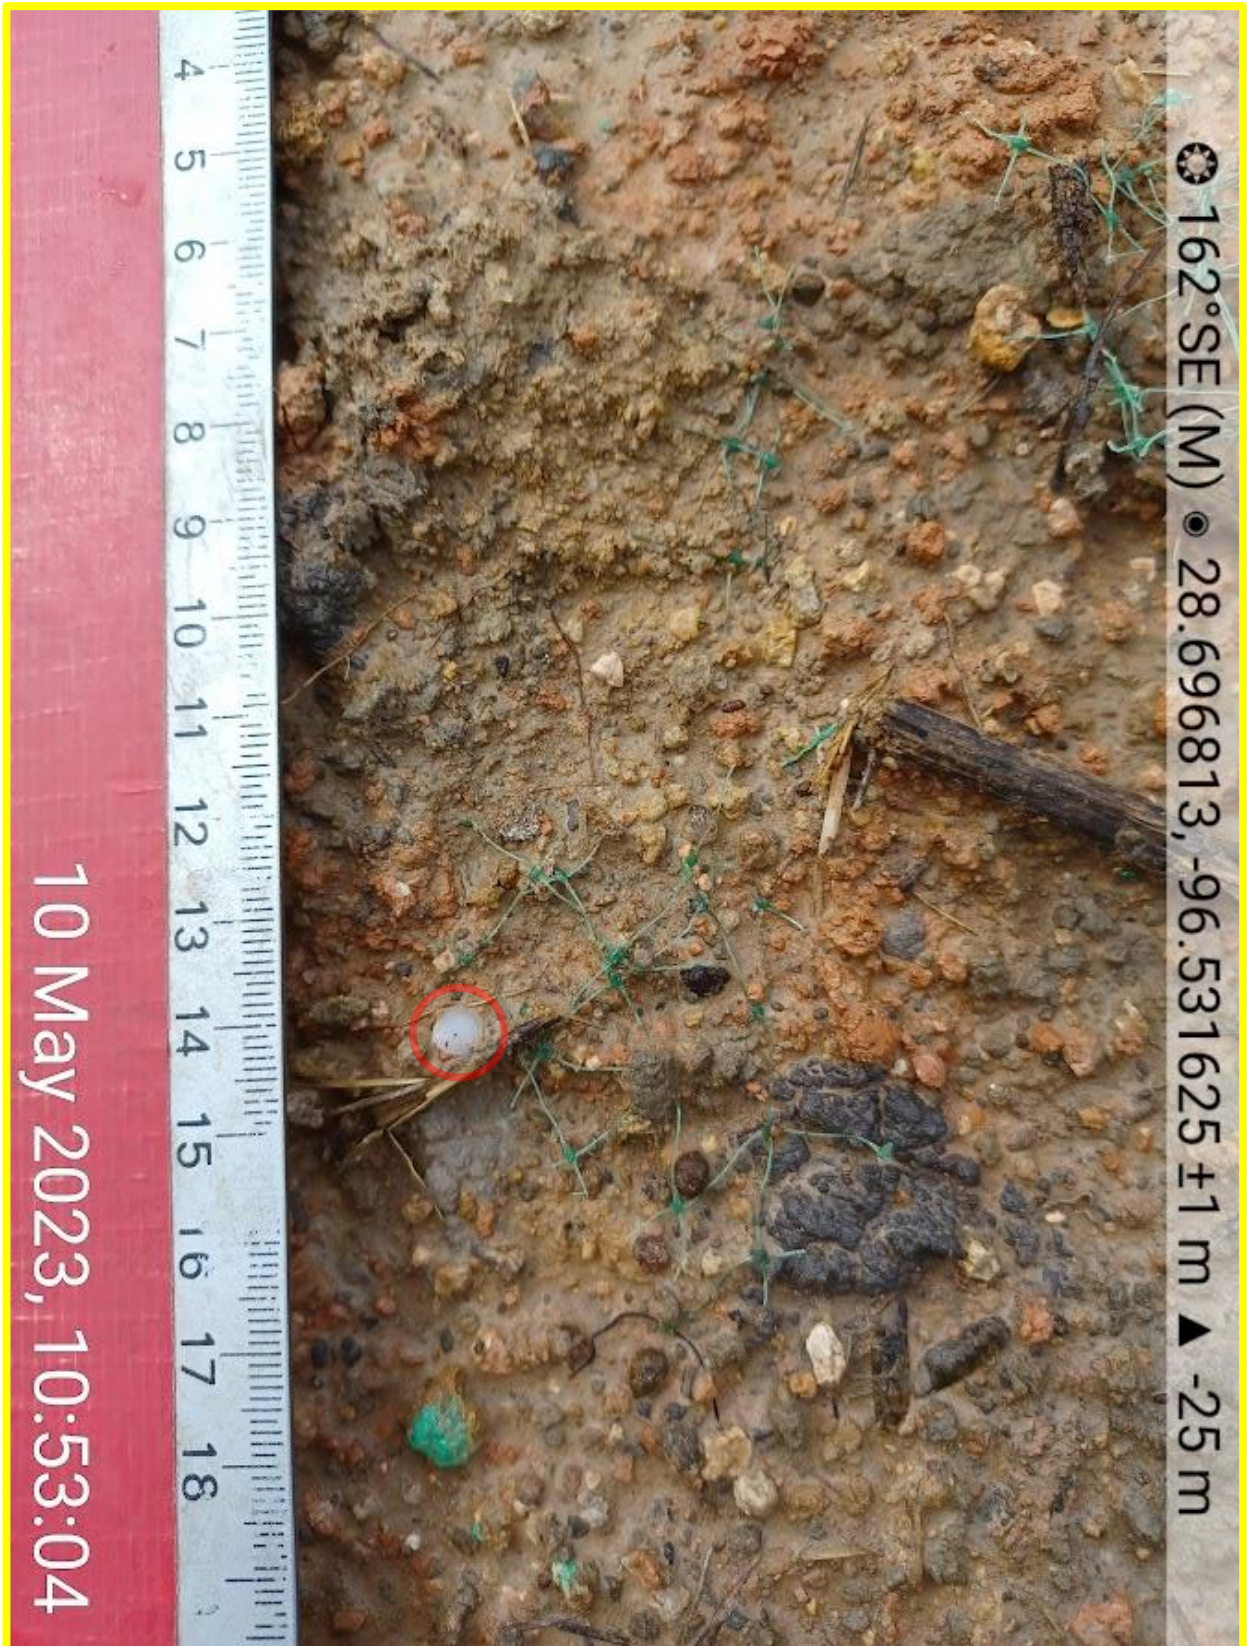
28.696813, -96.531633	Plastic pellets observed 1ft from fence, adjacent to flow reducers, on edge of flow path under silt fence	2023-05-10_008b	Yes
	28.696812, -96.531567	Plastic pellets observed in center of outfall channel, behind first row of flow reducers, in flow path	2023-05-10_008c	Undetermined
009	28.700507, -96.532057	Plastic pellets observed 15ft S of NW fence corner, at base of fence	2023-05-10_009a	Undetermined

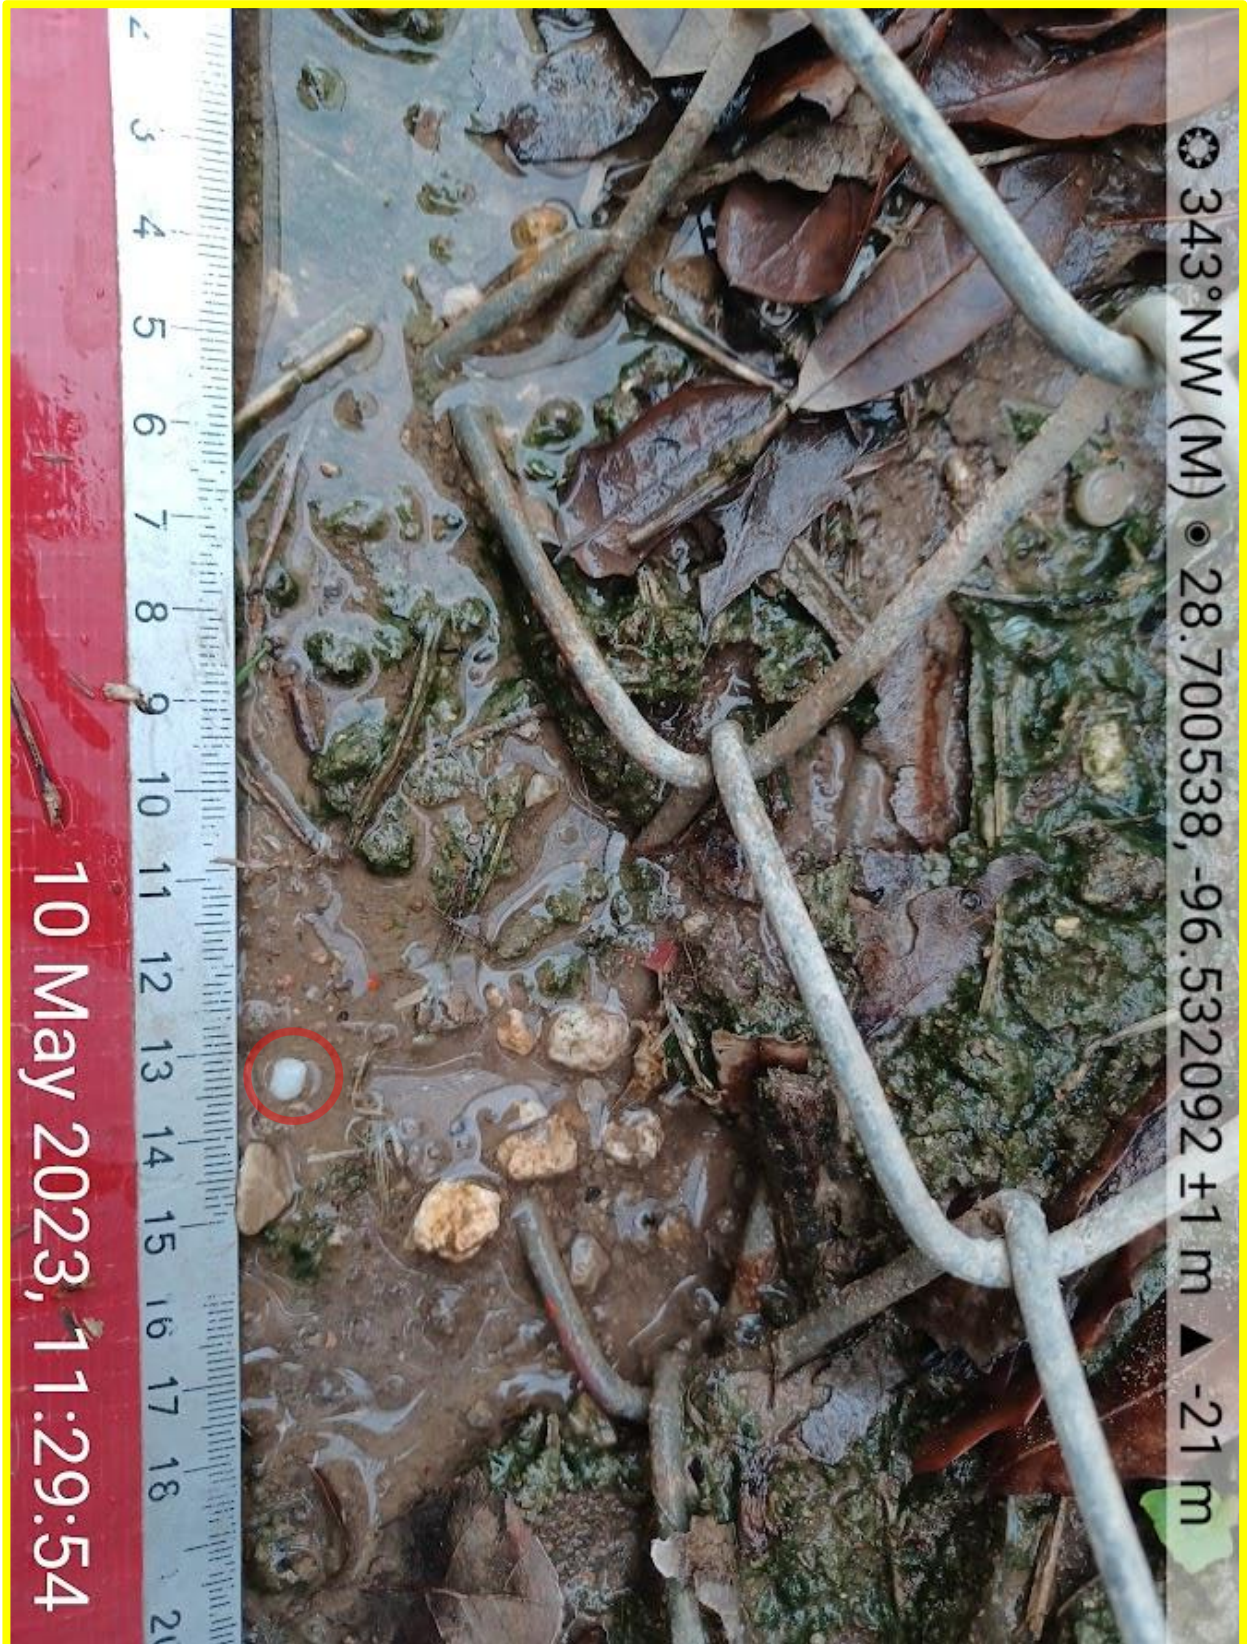
28.700538, -96.532092	Plastic pellets observed in NW fence corner, at base of fence	2023-05-10_009b	Undetermined
	28.700215, -96.532112	Plastic pellets observed 3ft from grate, in center of outfall channel	2023-05-10_009c	Yes
012	28.706215, -96.529408	Plastic pellets observed in center of outfall channel, 20ft from fence	2023-05-10_012	No
014	28.709705, -96.530013	Plastic pellets observed on N side of outfall at the high-water line	2023-05-10_014	No

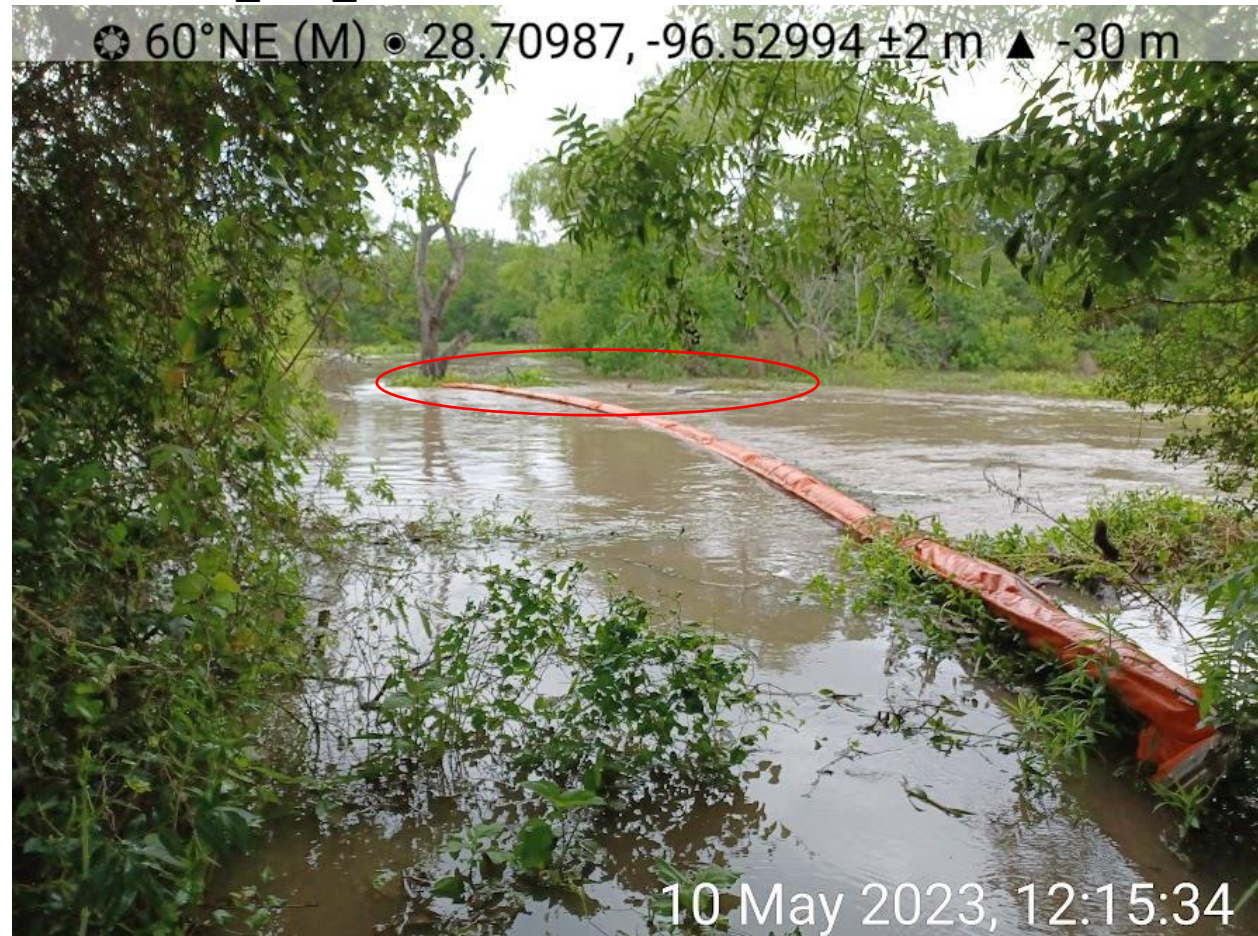
2023-05-10_014_S1

- New discharge observed at outfalls 245, 003, 008, and 009. See supplementary report for more details.
- Boom spanning the creek north of Outfall 014 had water flowing over it (See photo **2023-05-10_14_S1** on pg.34).
- Fence south of Outfall 014 was damaged during storm (See photo **2023-05-10_14_S1** on pg.35).
- Silt fence damage observed, conditions available on page 36.

Boom that stretches across creek north of Outfall 014 had water flowing over top of it on the far side, in area highlighted by red oval.

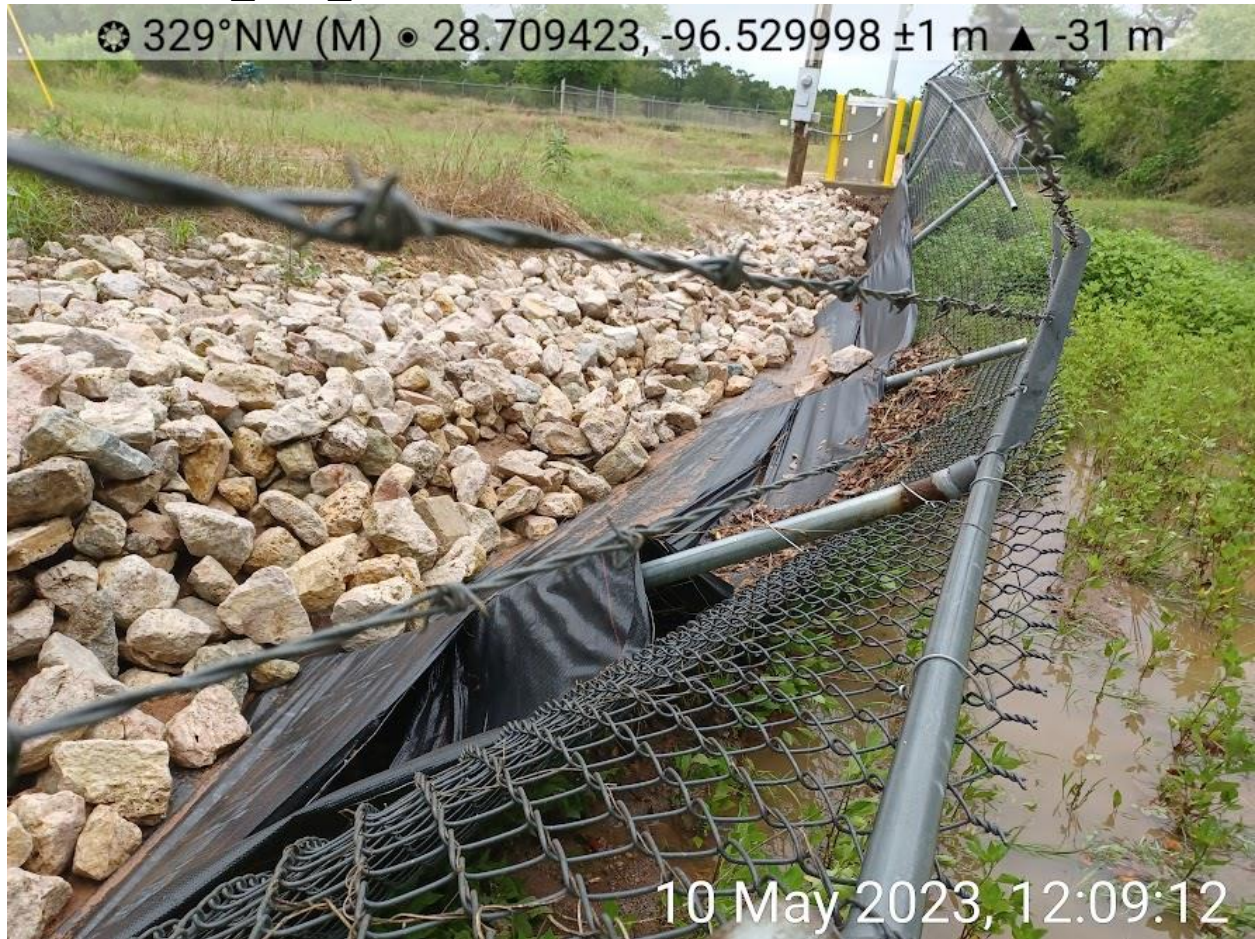
2023-05-10_014_S2

Fence line south of Outfall 014 laid over due to water flow.

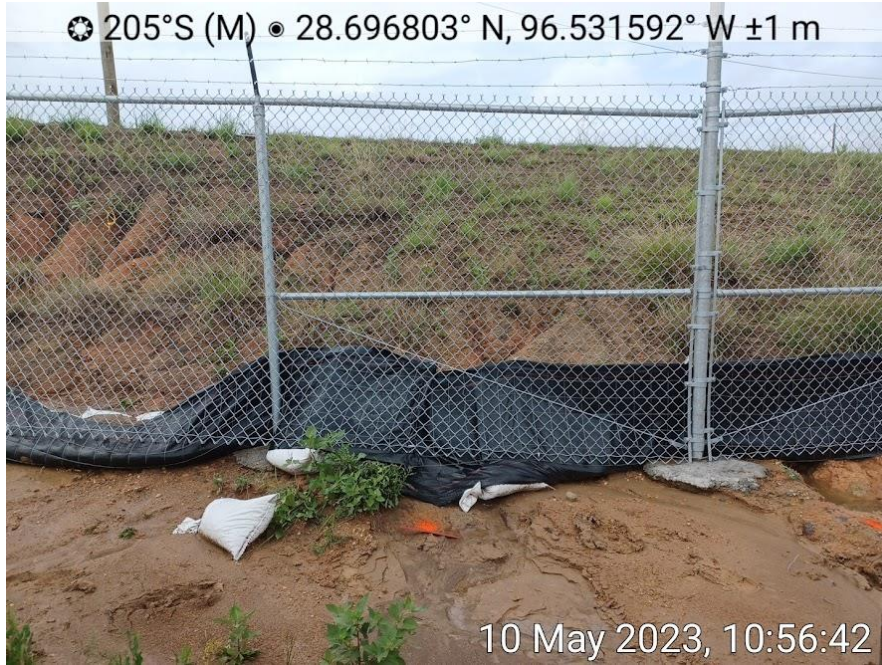
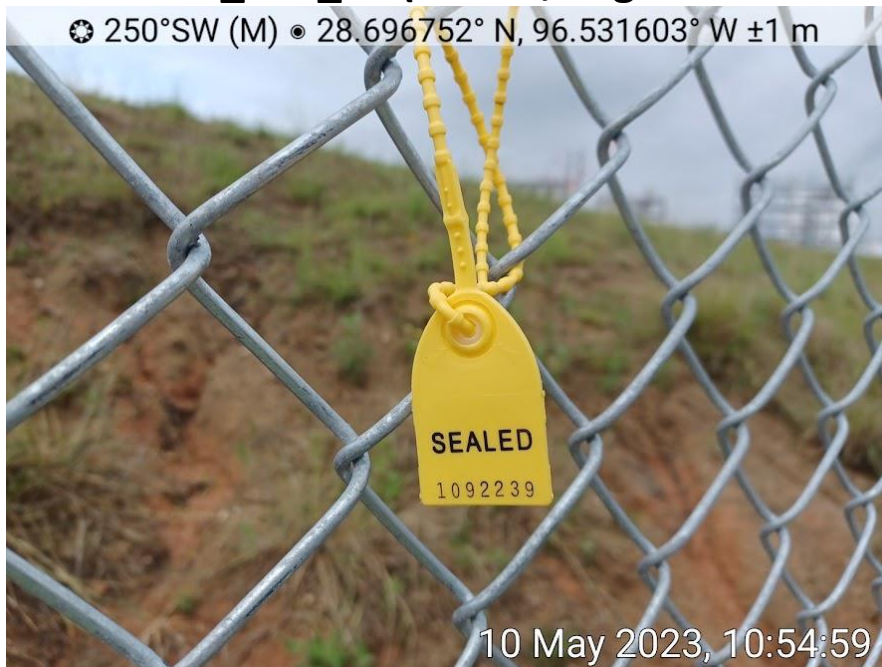
2023-05-10_008_S1 (Item 1, Tag ID: 1092239)

ITEM	TAG ID	LAT/LONG	DATE FIRST OBSERVED	DATE REPAIR OBSERVED	PHOTO ID	Pg. #	LOCATION/DESCRIPTION
1	1092239	28.696803, -96.531592	5/10/2023	N/A	2023-05-10_008_S1	38	Section of silt fence washed out at Outfall 008, adjacent to beginning of flow reducers.
2	1092274	28.693, -96.528527	5/10/2023	N/A	2023-05-10_007_S1	39	Section of silt fence between Outfalls 007 and 008 washed out.

Silt fence adjacent to the flow reducers at Outfall 008. Silt fence was blown out due to flow, sandbags were washed under silt fence as a result of the damage.

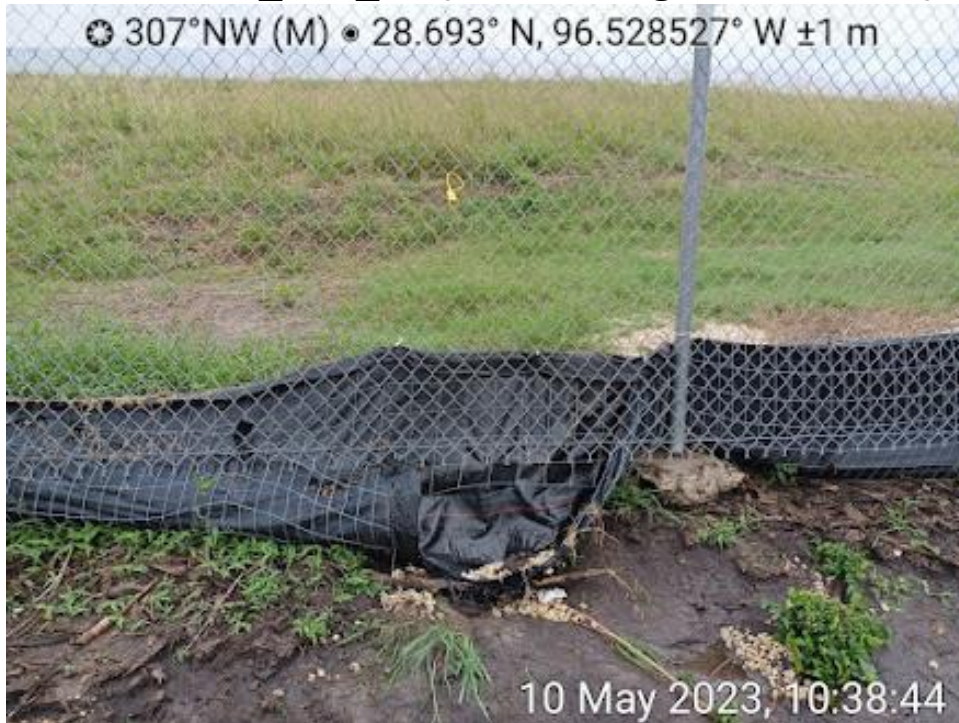
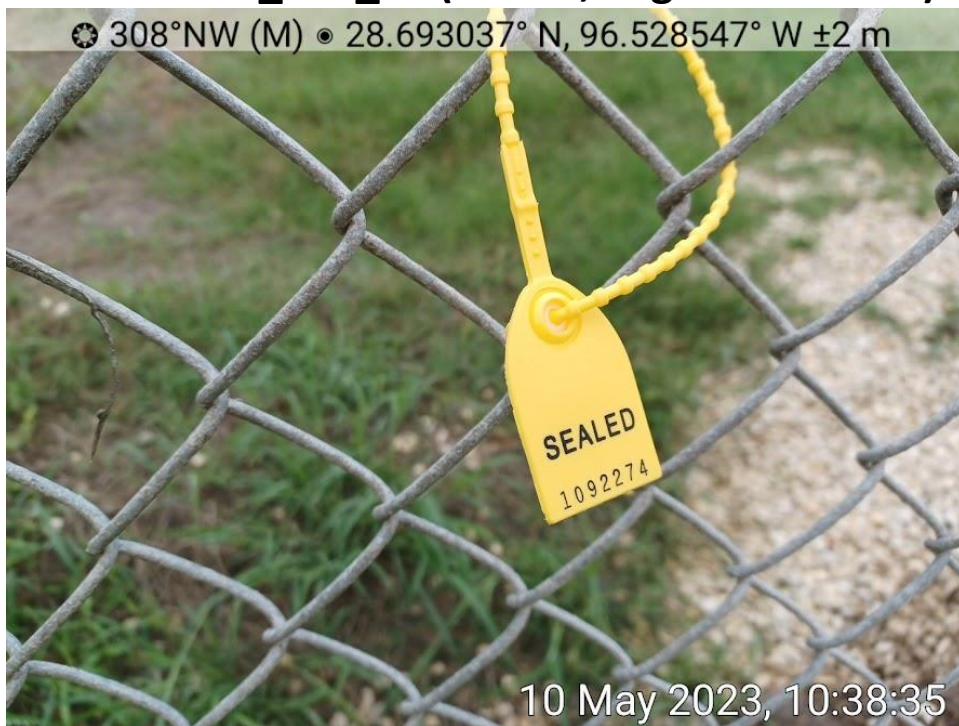
2023-05-10_007_S1 (Item 2, Tag ID: 1092274)

Silt fence North of Outfall 007 was washed out during recent rains.
