GLOBAL ENVIRONMENTAL ASSESSMENTS AND RESPONSE

COX CREEK MONITORING REPORT

SUBMITTED:
May 15, 2023

May 10, 2023

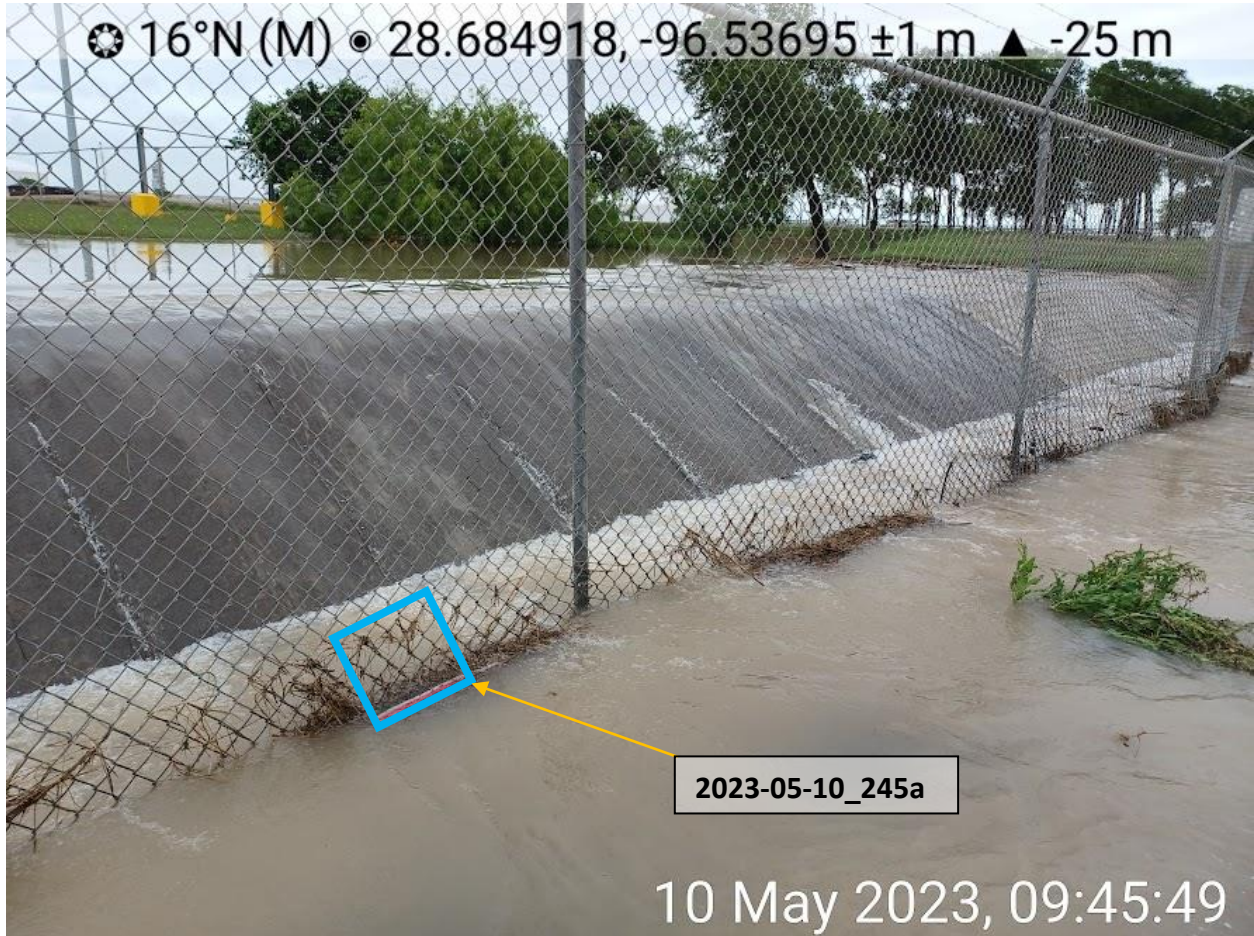
OUTFALL	LAT/ LONG	DESCRIPTION	PHOTO ID	EVIDENCE OF NEW DISCHARGE³ (Yes/No/ Undetermined)
2/4/5	28.684918, -96.53695	Plastic pellets observed at base of fence, in debris, in center of outfall	2023-05-10_245a	Yes

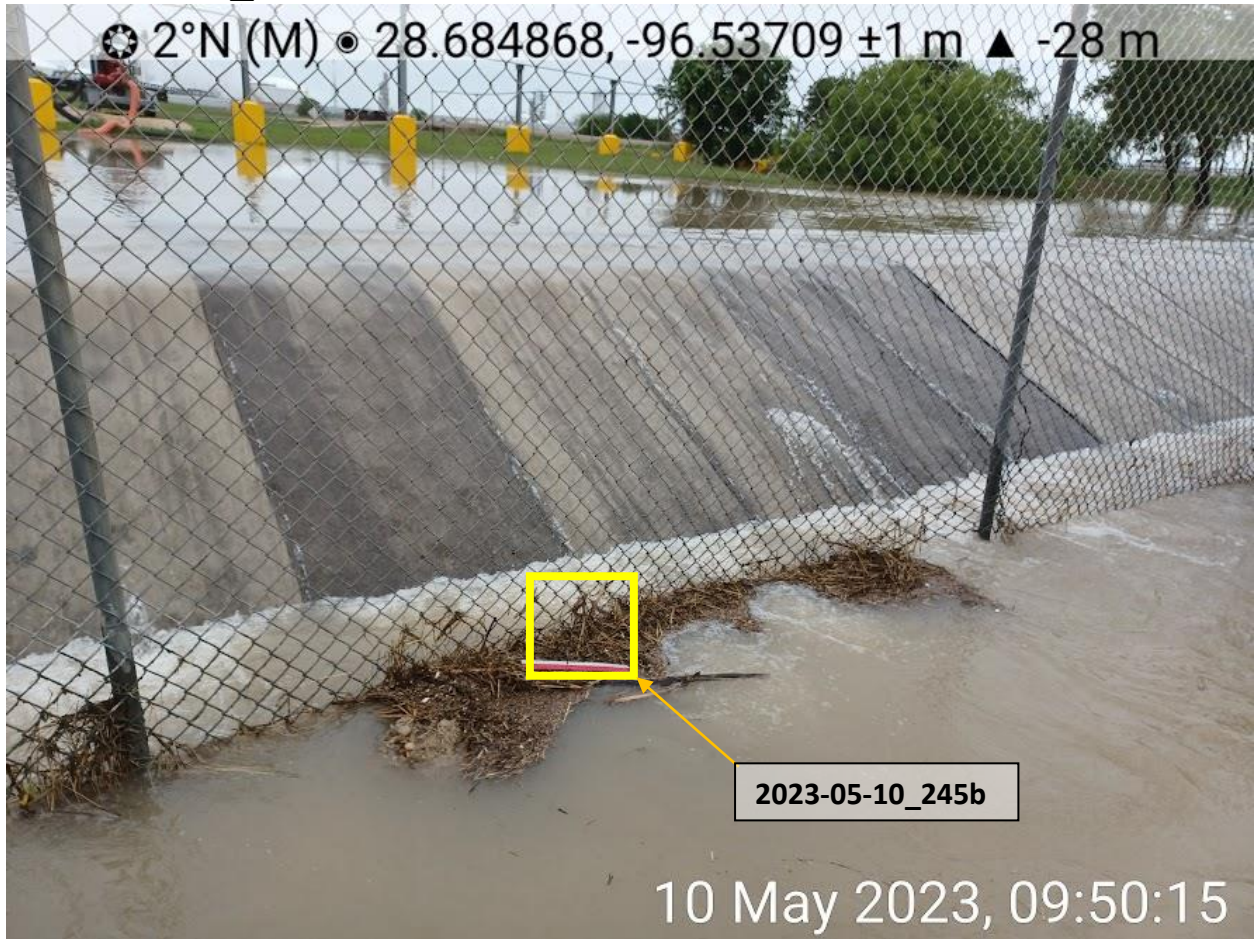
28.684868, -96.53709	Plastic pellets observed at base of fence, in debris, in center of outfall	2023-05-10_245b	Yes
003	28.6796, -96.548115	Plastic pellets observed in outfall channel, in debris line, 1ft from fence	2023-05-10_003	Yes
006	28.688725, -96.529258	Plastic pellets observed at base of fence, 30ft S of outfall channel	2023-05-10_006a	No

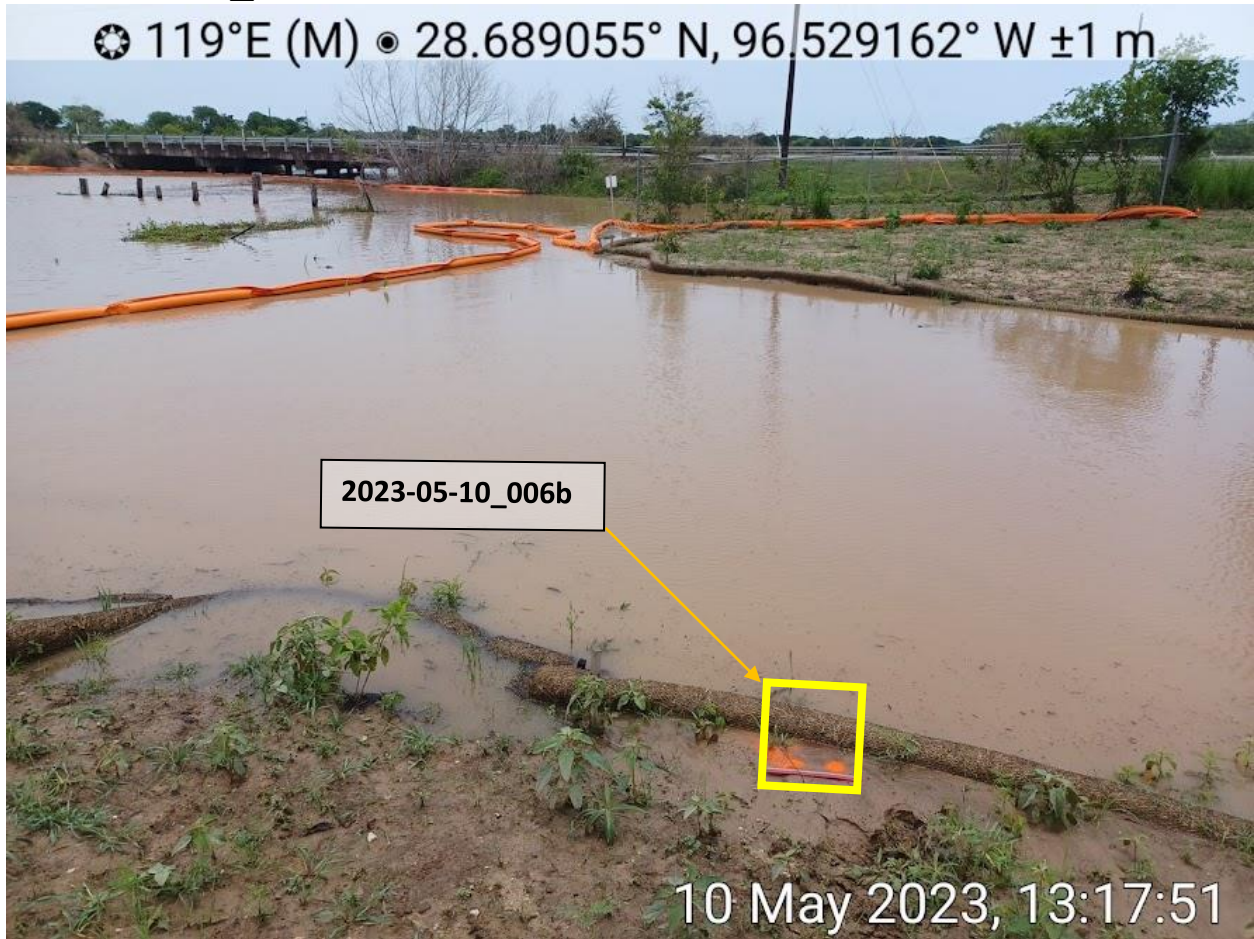
28.689055, -96.529162	Plastic pellets observed N side of outfall channel, at base of erosion control sock	2023-05-10_006b	No
007	28.692445, -96.528788	Plastic pellets observed 40ft N of outfall boom, 15ft from road	2023-05-10_007	No
008	28.696793, -96.531588	Plastic pellets observed 1ft from fence, adjacent to flow reducers, in flow path at silt fence blow out	2023-05-10_008a	Yes

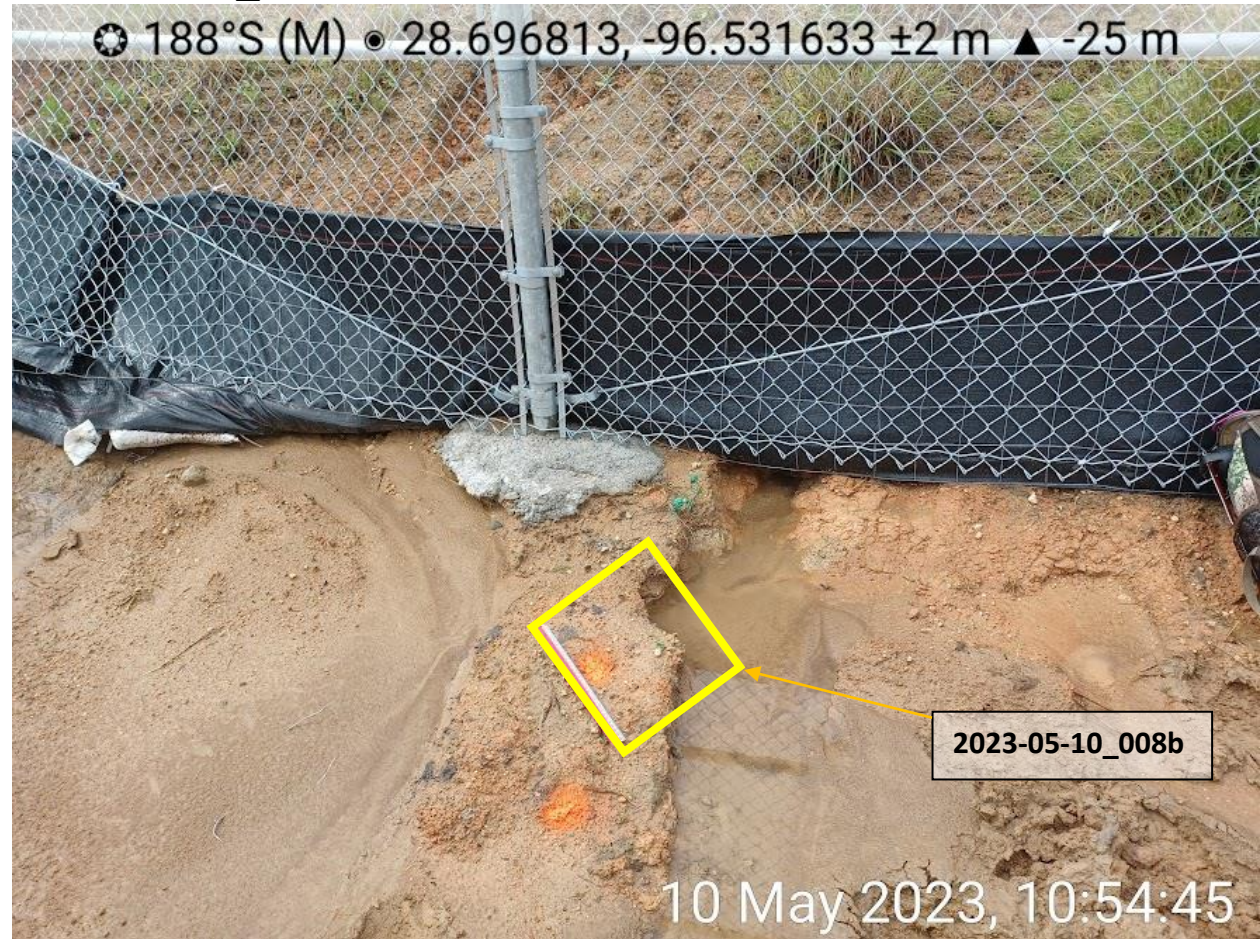
28.696813, -96.531633	Plastic pellets observed 1ft from fence, adjacent to flow reducers, on edge of flow path under silt fence	2023-05-10_008b	Yes
	28.696812, -96.531567	Plastic pellets observed in center of outfall channel, behind first row of flow reducers, in flow path	2023-05-10_008c	Undetermined
009	28.700507, -96.532057	Plastic pellets observed 15ft S of NW fence corner, at base of fence	2023-05-10_009a	Undetermined

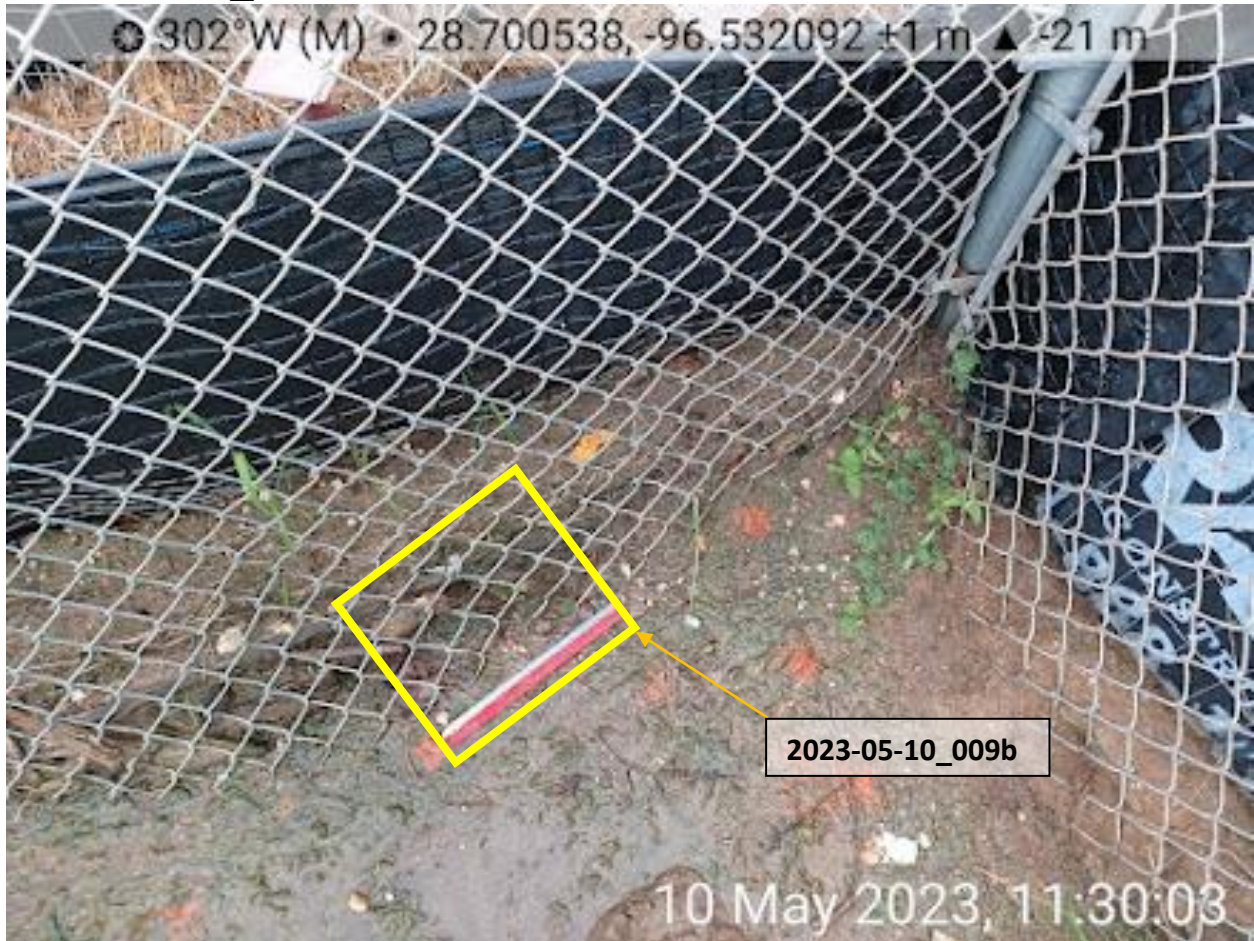
28.700538, -96.532092	Plastic pellets observed in NW fence corner, at base of fence	2023-05-10_009b	Undetermined
	28.700215, -96.532112	Plastic pellets observed 3ft from grate, in center of outfall channel	2023-05-10_009c	Yes
012	28.706215, -96.529408	Plastic pellets observed in center of outfall channel, 20ft from fence	2023-05-10_012	No
014	28.709705, -96.530013	Plastic pellets observed on N side of outfall at the high-water line	2023-05-10_014	No

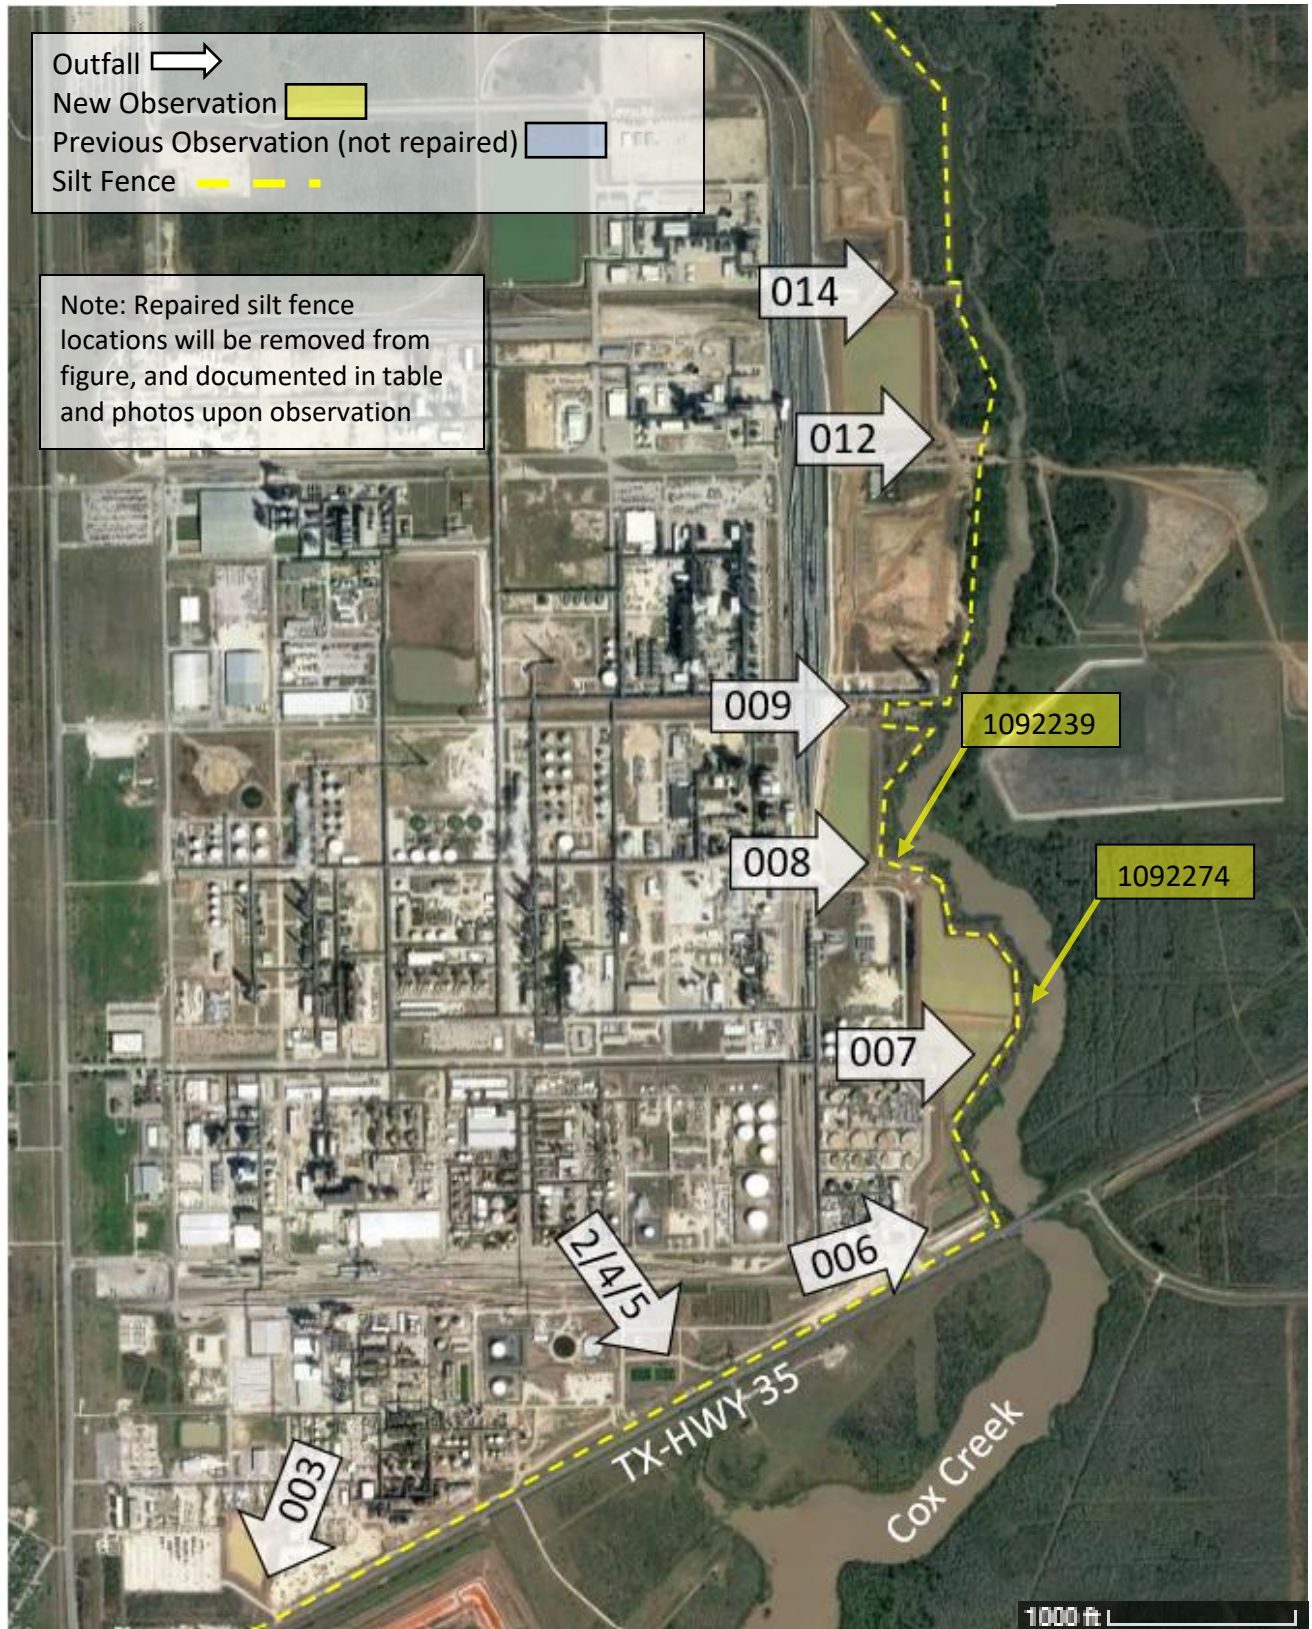
FIGURE 1: MAP OF OBSERVED SILT FENCE CONDITIONS ON 05/10/2023

ITEM	TAG ID	LAT/LONG	DATE FIRST OBSERVED	DATE REPAIR OBSERVED	PHOTO ID	Pg. #	LOCATION/DESCRIPTION
1	1092239	28.696803, -96.531592	5/10/2023	N/A	2023-05-10_008_S1	38	Section of silt fence washed out at Outfall 008, adjacent to beginning of flow reducers.
2	1092274	28.693, -96.528527	5/10/2023	N/A	2023-05-10_007_S1	39	Section of silt fence between Outfalls 007 and 008 washed out.
